INDOOR AIR QUALITY ASSESSMENT

**Department of Public Health
Pappas Rehabilitation Hospital, Nelson Building
3 Randolph Street
Canton, MA**

Prepared by:
Massachusetts Department of Public Health
Bureau of Environmental Health
Indoor Air Quality Program
November 2016

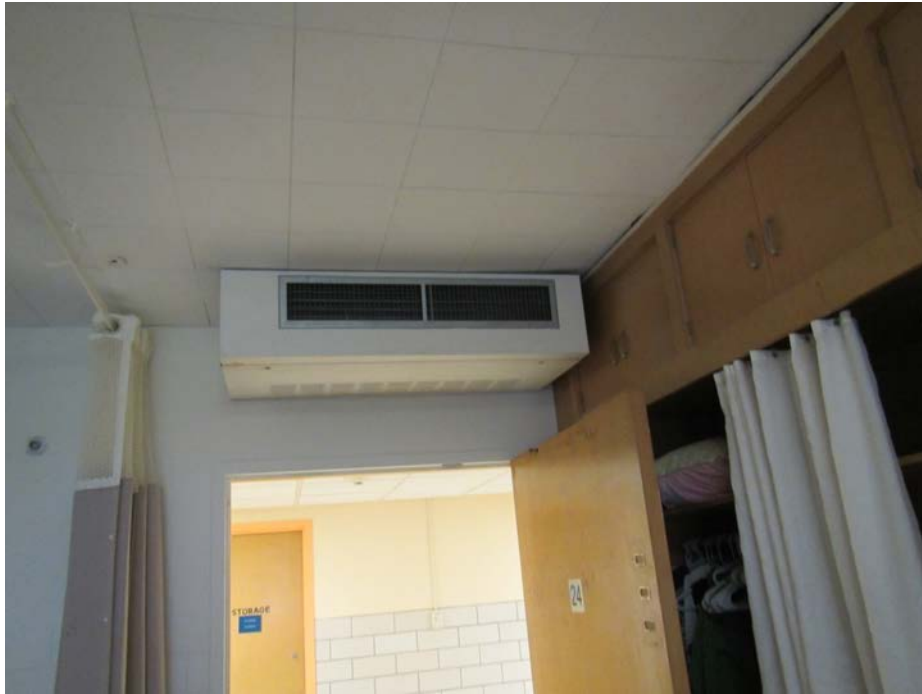
Picture 1

The NB has a number of different HVAC systems. Patient rooms and many common spaces have fan coil units (FCUs) located above or next to doors (Picture 1). These systems use heated water and a chilled water/glycol mixture to provide heated and cooled air respectively; the systems are switched over twice a year. Connected to the FCU system are ducted return vents located nearby in the room (Picture 2). FCUs are controlled by thermostats. Because the systems were still in cooling mode at the time of the visit and the outdoor weather was cool, these systems were not operating since no cooling was needed.

Fan coil unit above door in patient room

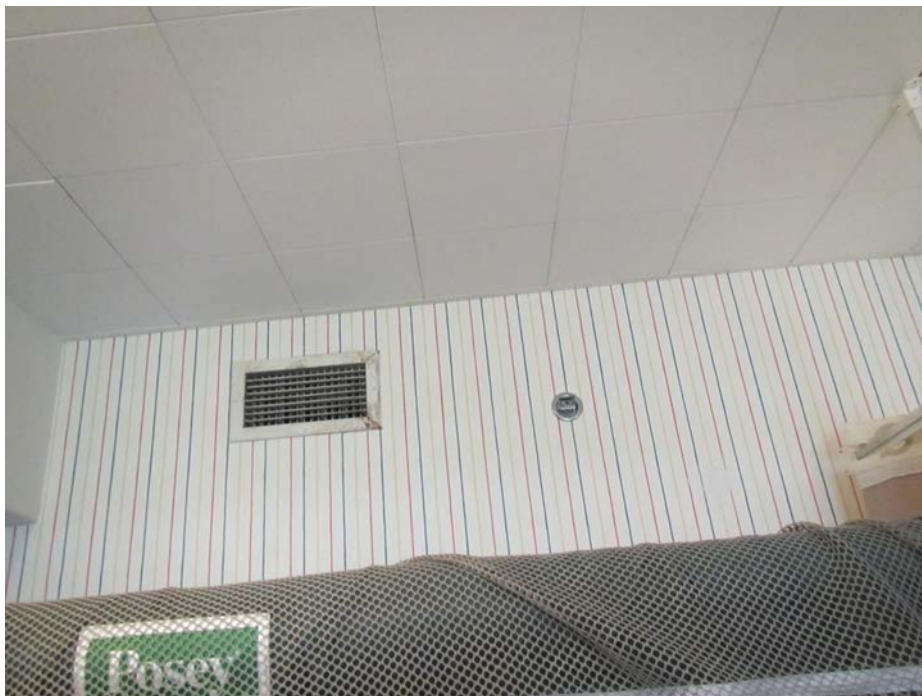
Picture 2

FCU return vent

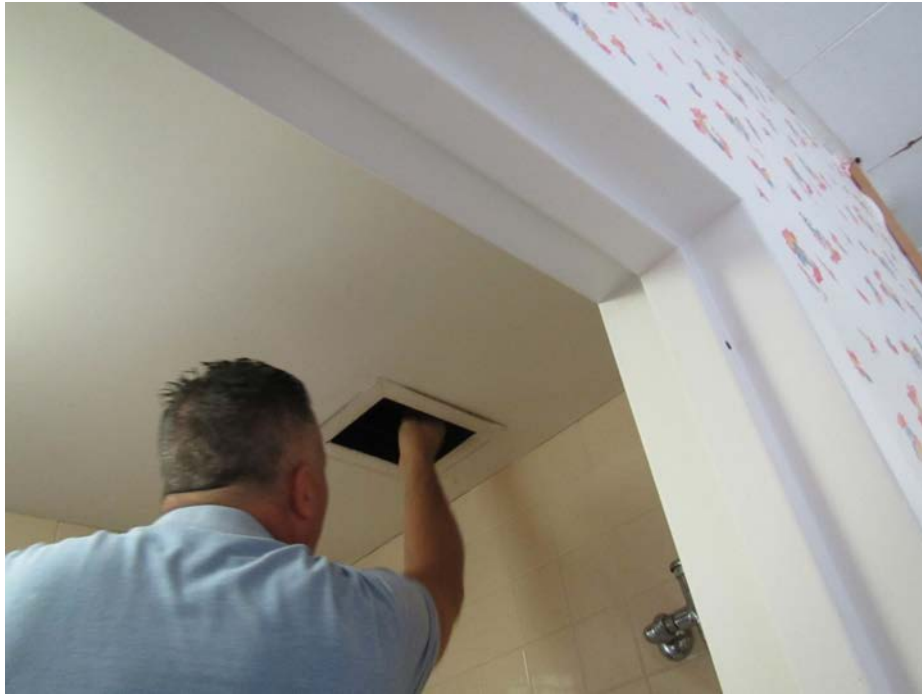
Picture 3

Exhaust ventilation in bathrooms are provided by exhaust vents connected to fans on the roof (Picture 3). Exhaust vents in about half the rooms in the Nelson II portion of the building were not drawing air (Table 2). During the visit, facility staff worked to determine the cause for lack of air removal. Without operable exhaust ventilation, bathroom-related odors and moisture cannot be removed and fresh air from open windows and hallways cannot be drawn into rooms. Note that although the patient bedrooms were unoccupied at the time of the visit, many of rooms had carbon dioxide levels close to 800 ppm; levels would be expected to be higher during

Restroom exhaust vent not drawing air

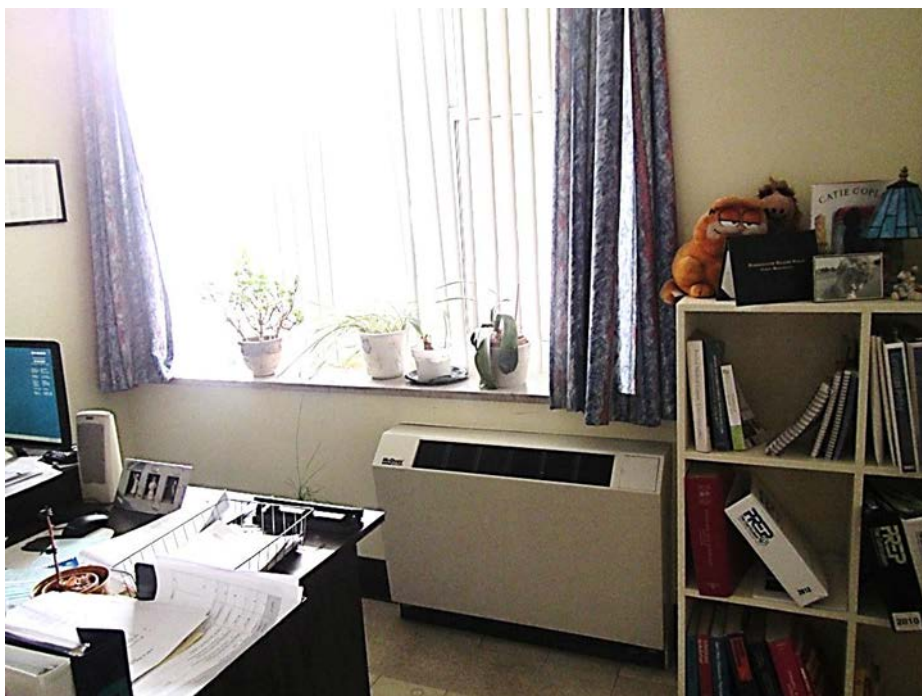
Picture 4

Many rooms are equipped with unit ventilators (univents, Picture 4), which draw air directly from a vent in the outside wall (Picture 5). Air drawn into the unit is filtered, heated (if needed), and circulated throughout the room. A univent also has a return vent along the bottom that draws in air that is mixed with fresh air before being circulated. At the time of the visit, only one of these units was operating. Staff report univents are operational and sometimes used for supplemental heating. It may be helpful to operate these units without heating during the spring/fall when FCUs are not needed for cooling or heating. Additional cooling and circulation in some areas is provided by window-mounted air conditioners (ACs, Picture 6) and portable ACs (Picture 7).

Unit ventilator (univent)

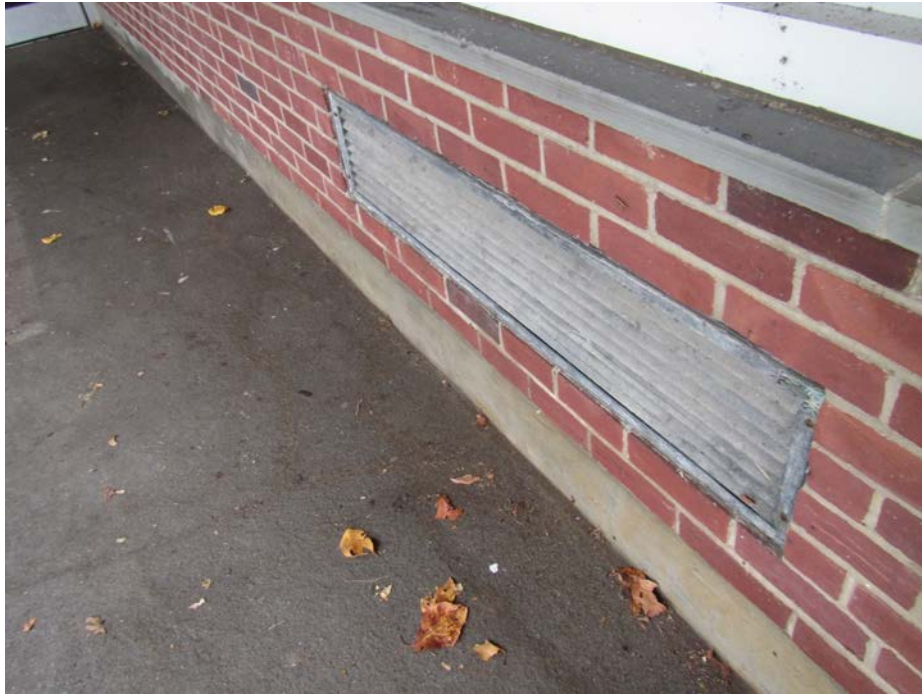
Picture 5

Univent fresh air intake

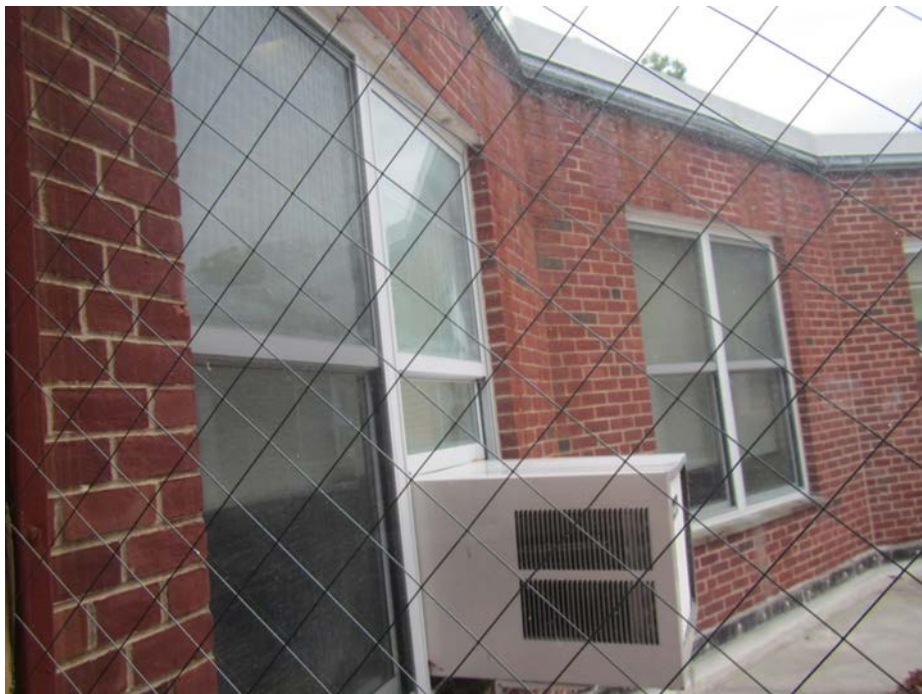
Picture 6

Window air conditioner

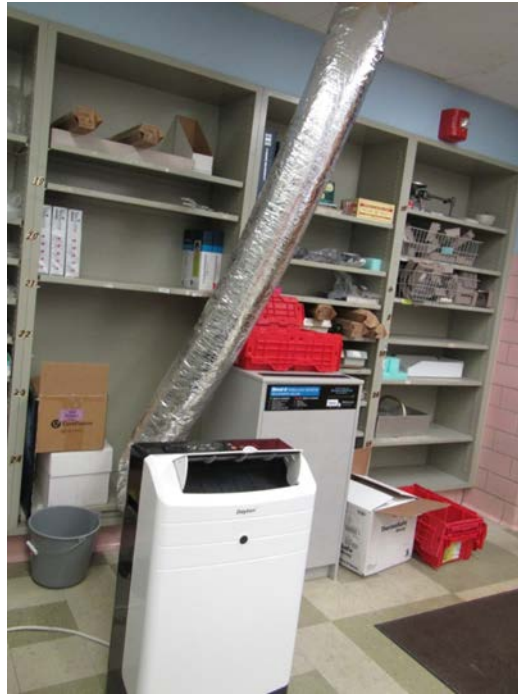
Picture 7

Portable air conditioner

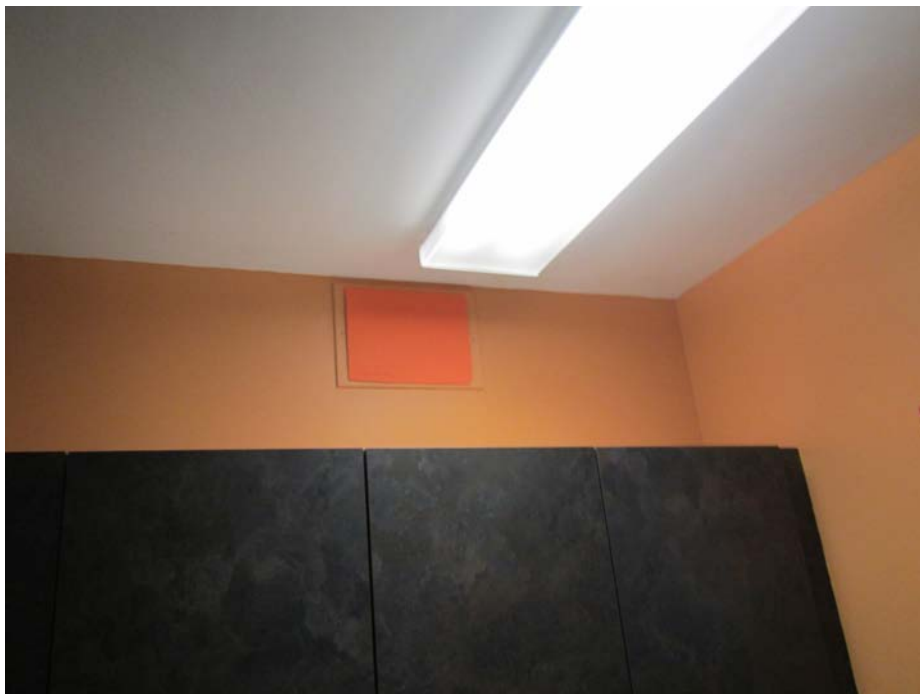
Picture 8

It was noted that the Dental Reception Office does not have fresh air or exhaust ventilation. There is a small transom-style vent in the wall into the adjoining room that was blocked from the reception office side (Picture 8). The adjoining room is used for dental equipment sterilization, which requires use of chemicals that produce odor. This vent should be sealed thoroughly from both sides. Methods to provide air circulation or ventilation to the Dental Reception Office include fresh air ventilation from the general HVAC system, a passive vent in the wall shared with the waiting room, or a through-wall fan that moves air in from the waiting room to the office. In addition, measures should be taken to ensure that the exhaust vent in the sterilization room is operational and on at all times chemicals are in use.

Covered vent in the Dental Office Reception leading to the sterilization room

11. Ensure that the dental sterilization room has operable exhaust that is activated anytime chemicals are used in that room.
12. For buildings in New England, periods of low relative humidity during the winter are often unavoidable. Therefore, scrupulous cleaning practices should be adopted to

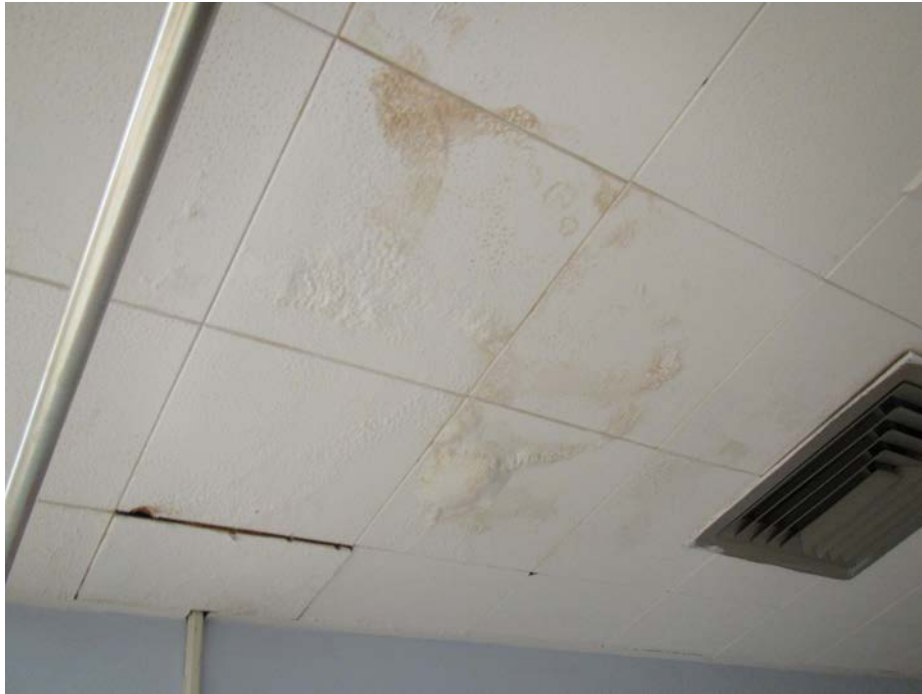
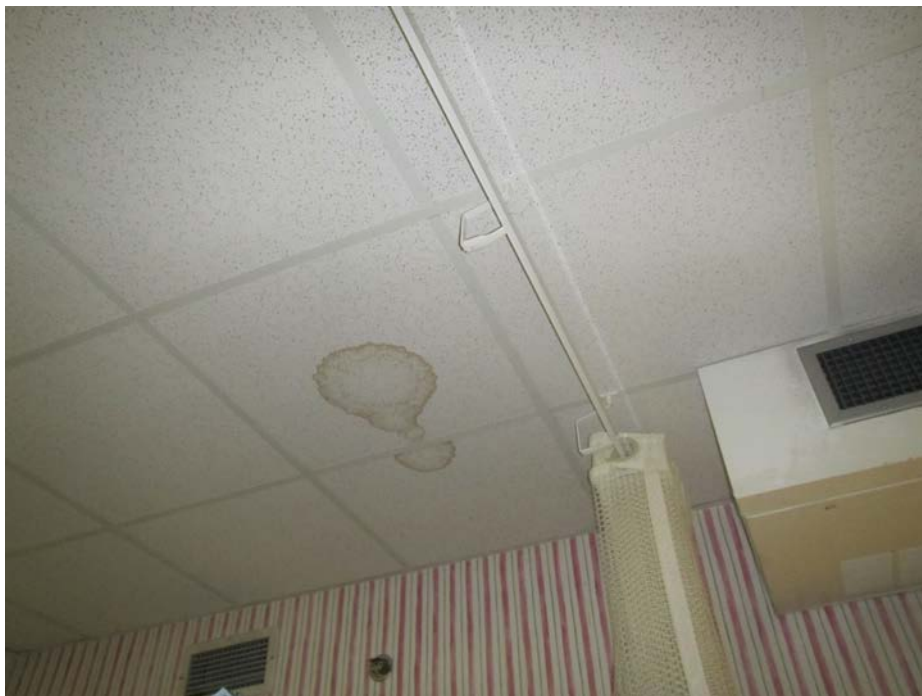
Water-damaged ceiling tiles were observed in several areas (Pictures 9 and 10). These indicate that leaks from the building envelope, plumbing, or HVAC system are occurring. The leaks should be addressed and the ceiling tiles replaced as they can be a source of mold if chronically moistened. Note that some of the water-damaged tiles are of an interlocking type that may be glued directly to the ceiling; these may be difficult to replace.

Water-damaged interlocking ceiling tiles

Water-damaged ceiling tile

13. Remediate leaks leading to water-damaged ceiling tiles and replace the tiles when possible.
 14. Consider means to improve drainage around the building to prevent water infiltration leading to water damage such as shown in Picture 11, including removing and trimming back plants from around the building. Clean and patch the plaster in the stairwell to prevent dust generation.

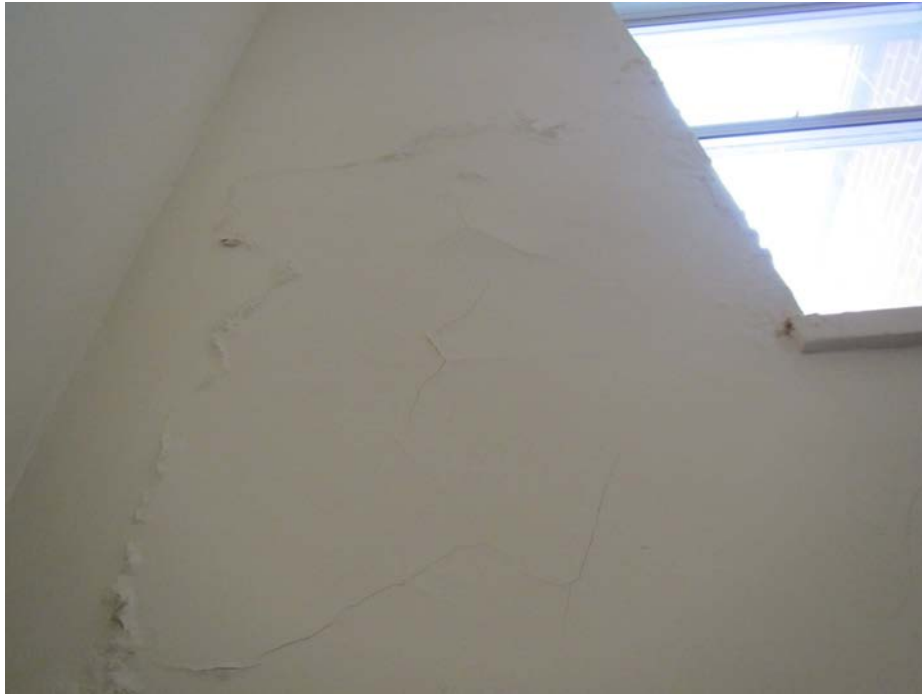
Picture 11

Water-damaged plaster was observed in a stairwell (Picture 11) to the lower level. This indicates that this wall, which is partly below-grade, is chronically damp. Improving drainage outside may reduce the amount of water infiltrating through the wall in this area.

Wall in stairwell with cracked and spalling water-damaged plaster

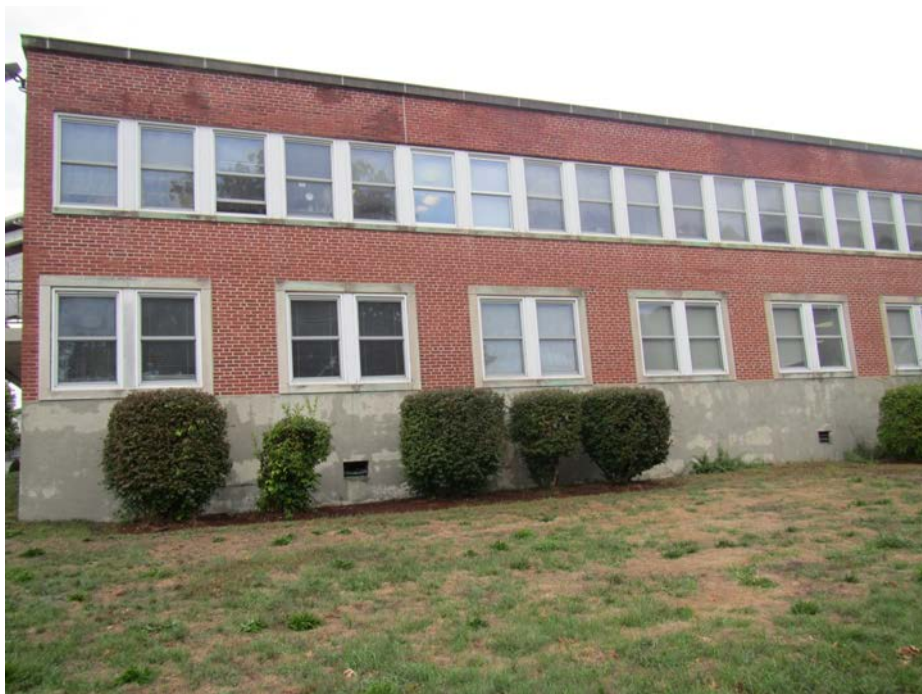
Picture 12

Outside the building, plants were observed next to the foundation (Picture 12) which can hold moisture against the side of the building and lead to deterioration as well as damage due to root infiltration. In addition, nearby plants can be a source of pollen and debris which can clog univent filters and infiltrate through open windows. Trees were also observed overhanging the roof, which can lead to debris that can clog roof/storm drain systems (Picture 13).

Shrubs next to exterior of building

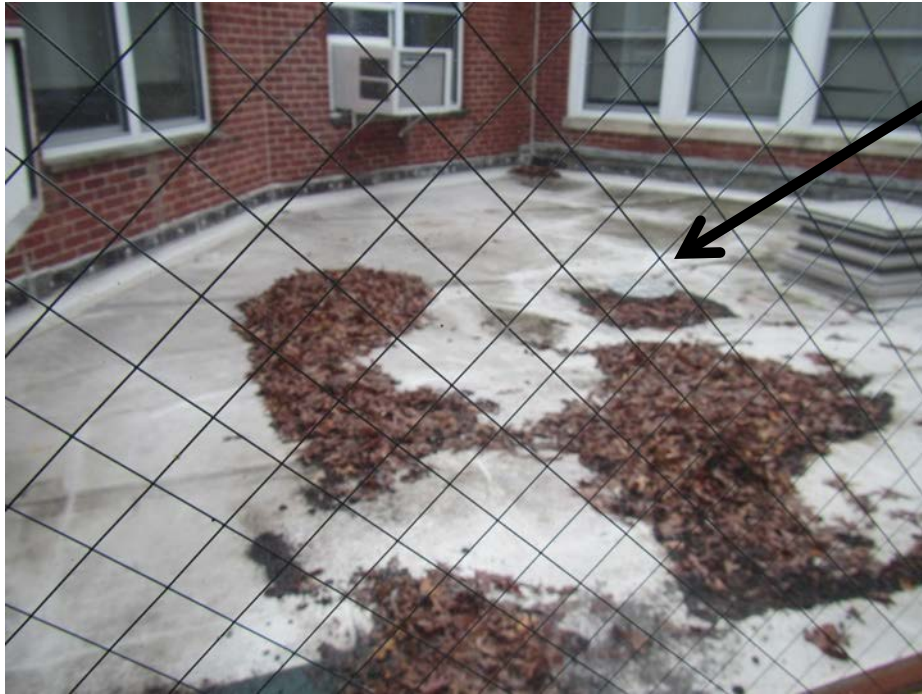
Picture 13

Leaves/debris on small roof segment including around storm drain (arrow)

15. Trim trees from overhanging the roof and remove leaves/debris from roof segments to prevent clogging of drain systems.
 16. Periodically inspect the seams between roof and wall segments and between the Nelson and Bradford buildings for damaged sealant and flashing and repair as necessary.

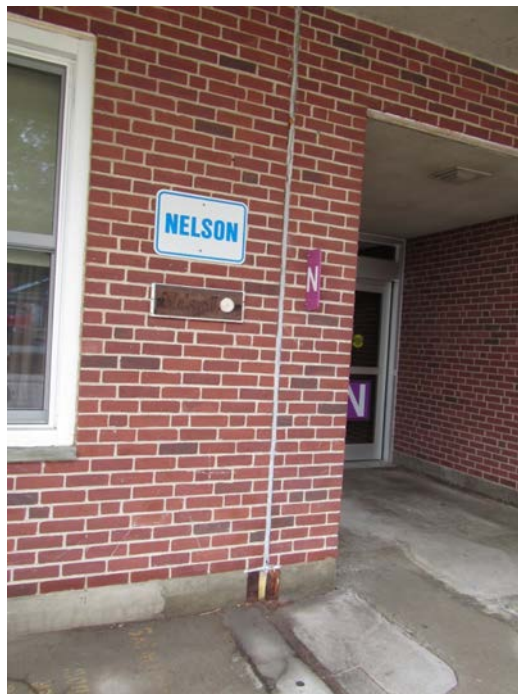
Picture 14

Note that the roof is a complex shape, with interior areas such as that shown in Picture 13. Seams where roof areas join walls can be a source of leaks if the roof and flashing are not maintained in good condition. The seam where the Nelson Building connects to the Bradford Building (Picture 14) may also be a source of leaks as the buildings settle. These areas should be periodically inspected for damage and deterioration. In addition, some doors to the exterior lacked weather stripping (Picture 15), which can allow moisture and pests into the building.

Seam between Nelson and Bradford buildings

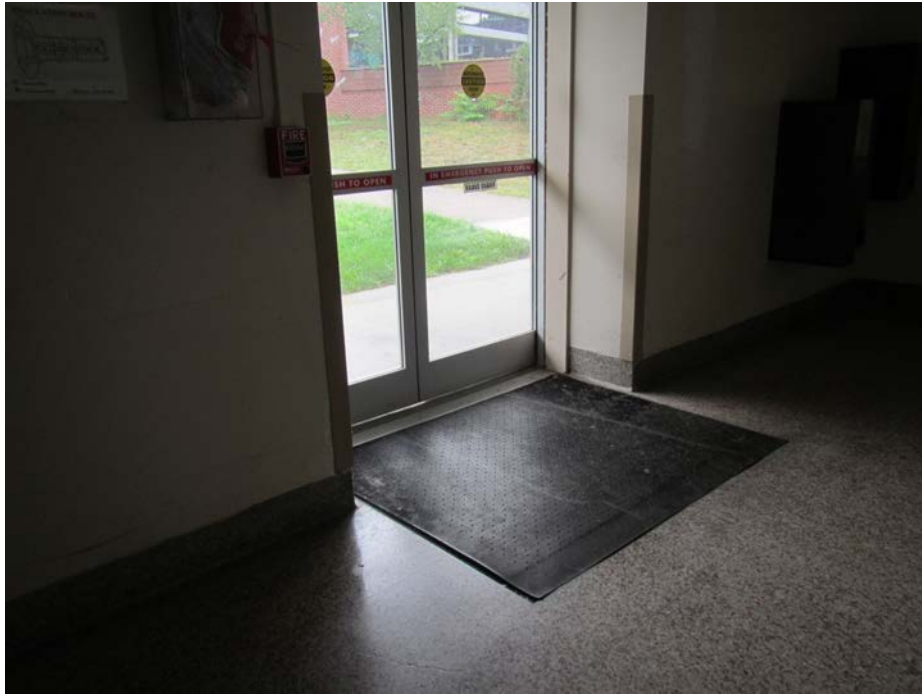
Picture 15

Light visible beneath door showing lack of weather stripping

17. Install or replace weather stripping on exterior doors so that no light is visible beneath or around them.
 18. Catalog and inspect floor drains and unused plumbing fixtures. For those which are not regularly used, develop a program of watering on a regular basis to maintain the trap seal. If the drains are not likely to be used again, seal permanently.

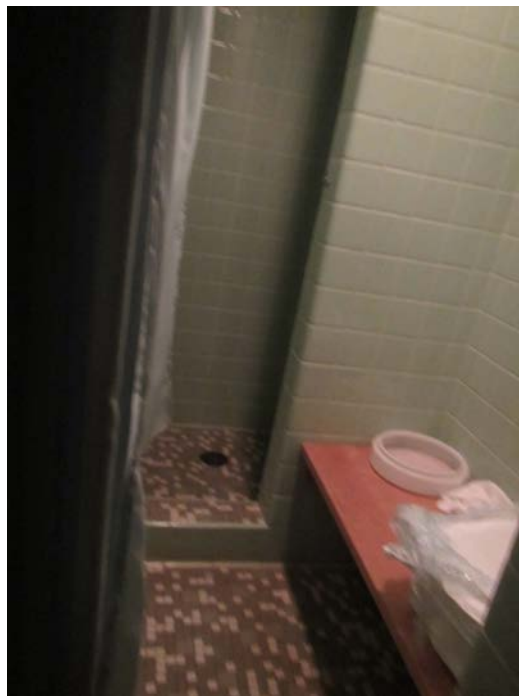
Picture 16

Floor drains are present in many areas of the NB. In some areas, these are clearly regularly used, but in others, they may not be regularly filled with water. For example, the old nurses' bathroom on the lower level appears to be used for storage (Picture 16); therefore, drains in this bathroom will likely become dry, which can allow sewer gases to infiltrate into occupied areas. Floor and other drains that are not regularly used should be periodically filled with water to maintain an intact trap seal. If these drains will not be used in the foreseeable future, they should be sealed.

Floor drain in disused shower on the lower level

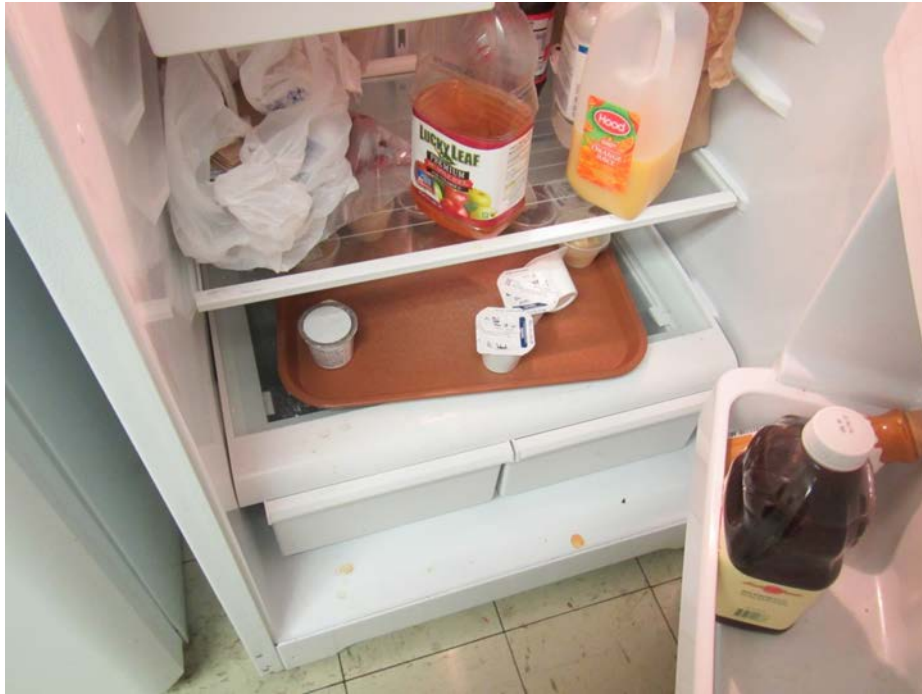
Picture 17

Refrigerators in some areas, including the nurses' station, had evidence of spills (Picture 17), which can be a source of odors and microbial growth. Refrigerators should be kept clean. Refrigerators and water dispensers were observed on top of carpet. Spills and leaks from these appliances can moisten the carpet and lead to microbial growth.

Spills inside fridge in nurses' area breakroom

20. Keep refrigerators clean to prevent odors.
 21. Consider moving water dispenser and refrigerators to areas without carpeting.
 22. Install a device on the equipment shown in Picture 18 to collect condensation and direct it to a drain. Discard any water-damaged porous materials in the basement.

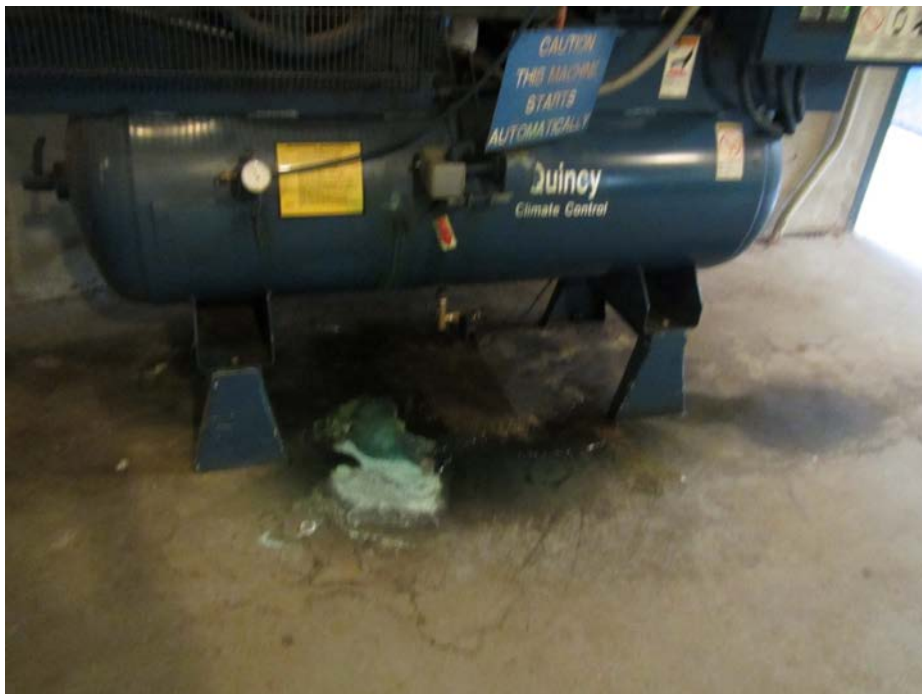
Picture 18

Condensate water from equipment on the floor of the mechanical room

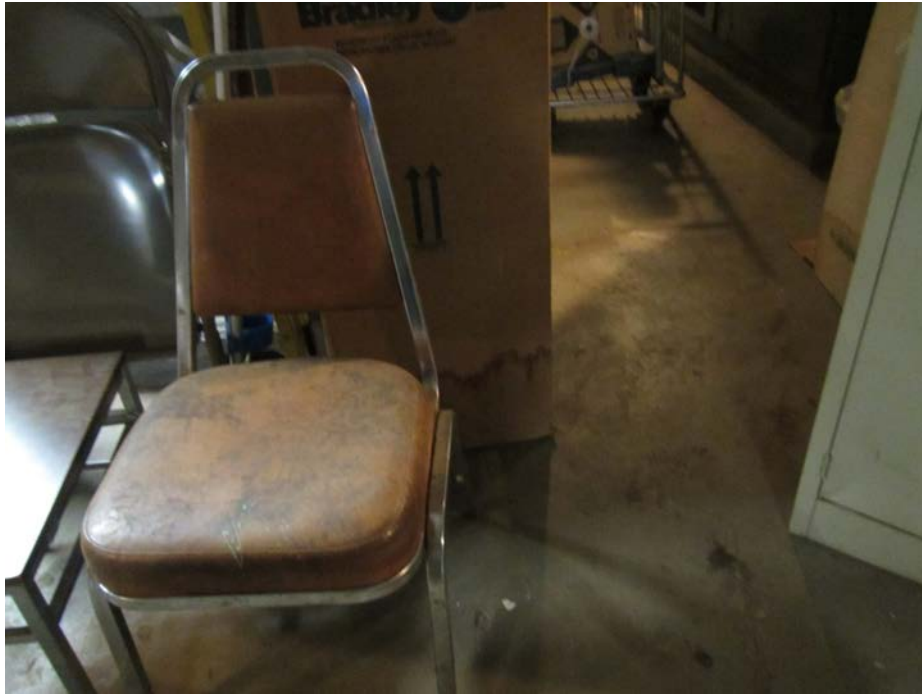
Picture 19

In the lower level, boxes and other porous items were observed on the floor in some storage areas. Since these are below grade, the floors may be subject to condensation on hot, humid days. Porous items should be kept off of floors to prevent water damage from condensation. Note that in the mechanical room there was evidence of water leaks and condensation on the floors (Picture 18) and some water-damaged boxes and other materials were found there (Picture 19). These should be discarded.

Water-damaged box and leather seat in mechanical room

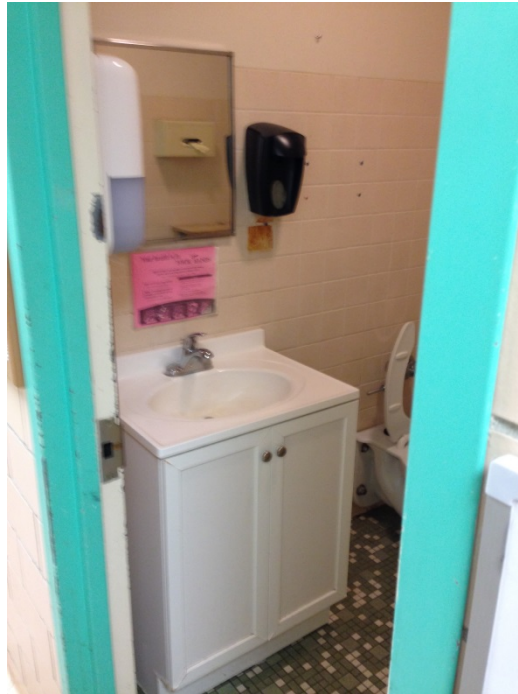
Picture 21

Staff in the NB reported foul odors in and around restrooms of the NB nurses station. A conference room near the nurse's station is currently used as a breakroom; the room has two refrigerators. During the initial August 2016 visit, the conference room/breakroom had a significant number of flies (Picture 20) that could be attributed to the amount of food observed in the breakroom. Since the break room and restroom are in proximity, it is likely that the foul odors from restroom (Picture 21) result from the use of the restroom sinks for beverage disposal and dishware cleaning. Food residue accumulated in the sink trap will cause foul odors. Of note

Restroom with reported foul odors in nurse's station

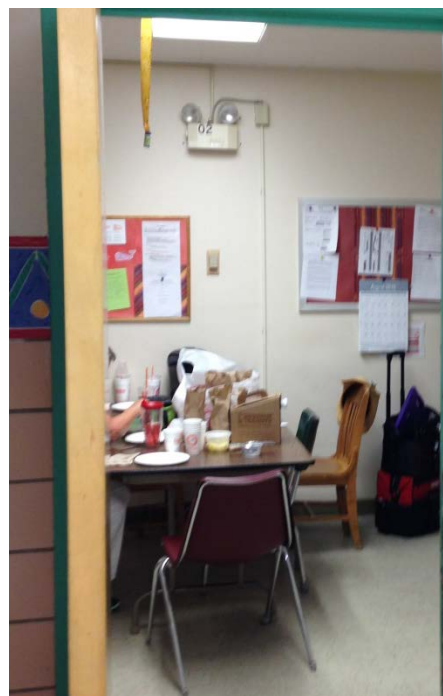
Picture 22

Open food containers in break room

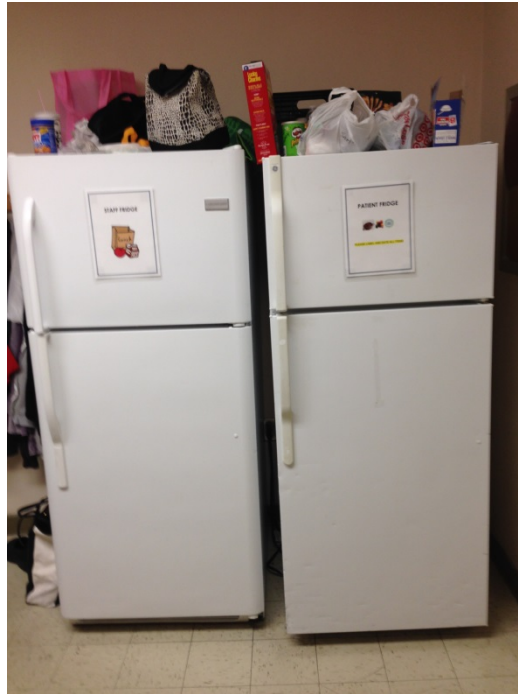
Picture 23

Food refrigerators in break room

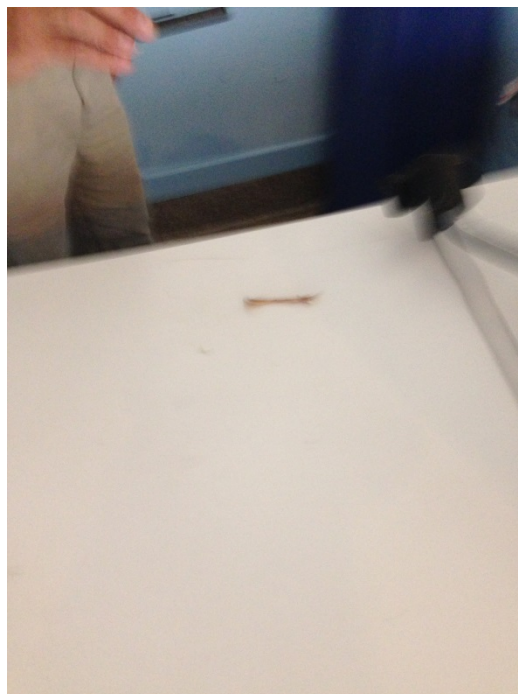
Picture 24

Chicken bone on a desk in the front waiting room

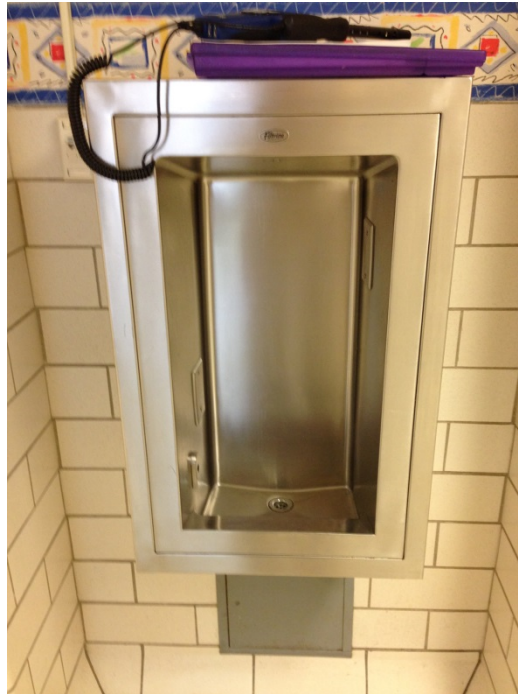
Picture 25

Flies can be a source of spread of bacteria and other microorganisms and must be eradicated from patient care areas. House flies tend to breed in warm, moist areas. Refrigerator condensation pans and open plumbing drains are likely locations for house fly breeding. Of note is that hallways contain abandoned water bubblers that appear to have open drains (Picture 25). The water bubbler drains should be sealed to eliminate potential house fly breeding locations and odors.

Abandoned water bubbler that appears to have open drains

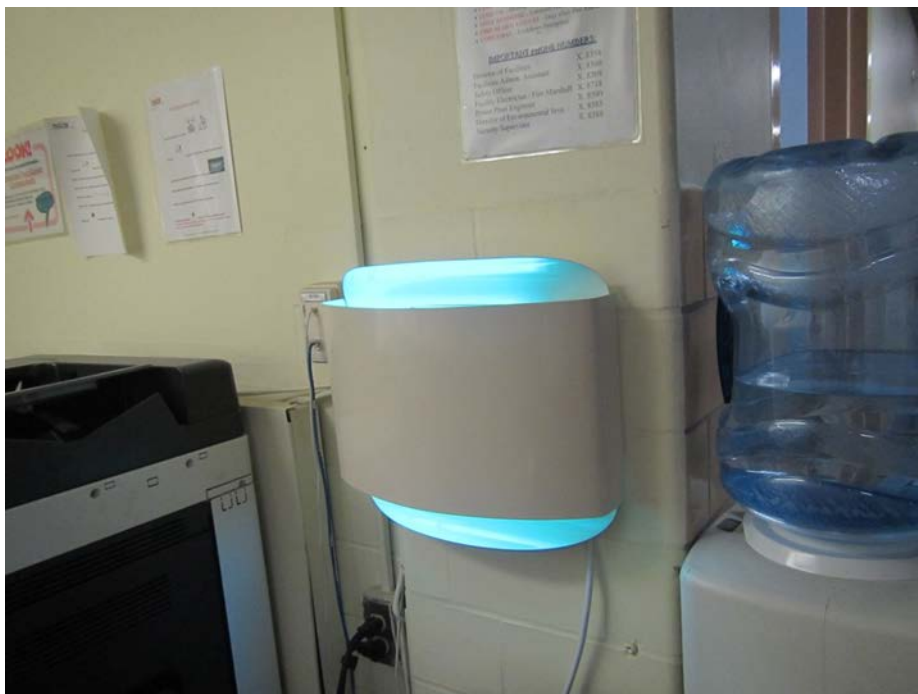
Picture 26

No flies were observed during the September 2016 visit. Note that wall-mounted light-based fly traps were in use in several areas of the Nelson Building (Picture 26); these traps were reportedly installed recently. These units need to be cleaned and maintained in accordance with manufacturer's instructions. If flies reoccur, the services of a licensed pest control professional should be used to develop a control program using the principles of Integrated Pest Management (IPM), which include exclusion of pests (e.g., tightly-sealed doors and window screens), removal of attractants (food and water) and harborage, and regular thorough cleaning.

Wall-mounted light-based fly trap
